Fire Test Report

Fire resistance test on a Tri-pro 315 Dia & 100 Dia single blade combination fire, smoke and volume control damper mounted in a 1 hour rated 100mm thick metal framed stud partition wall.

Test Number 1243 Dated 22 September 2010.

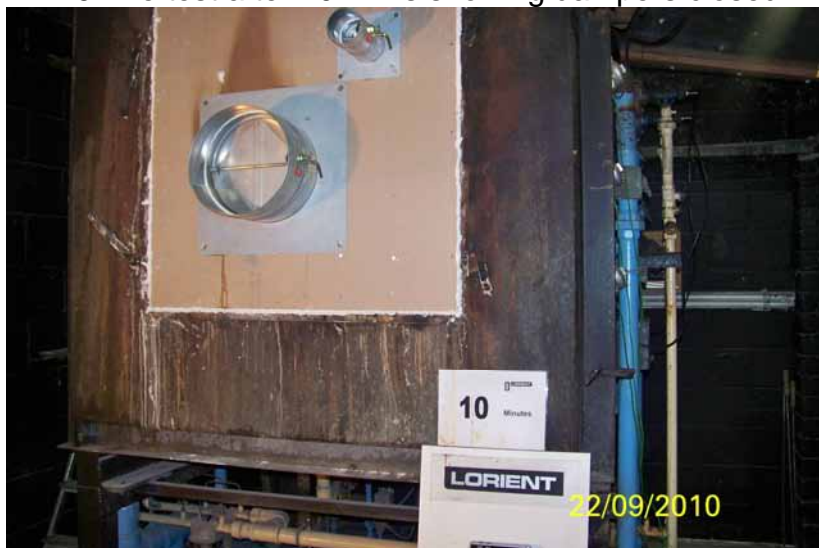
FTP 9 Fire test after 10 min's showing dampers closed.

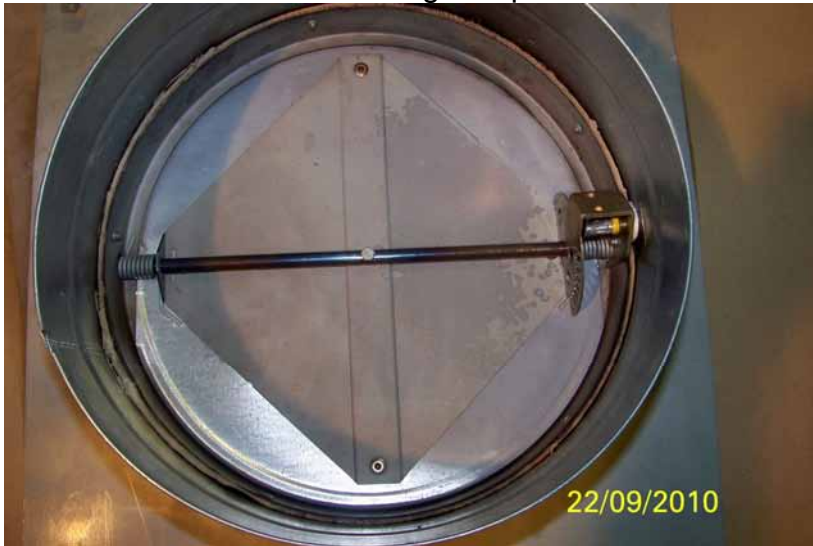
FTP 11 After 25 min's showing damper blade condition with furnace at 812°C

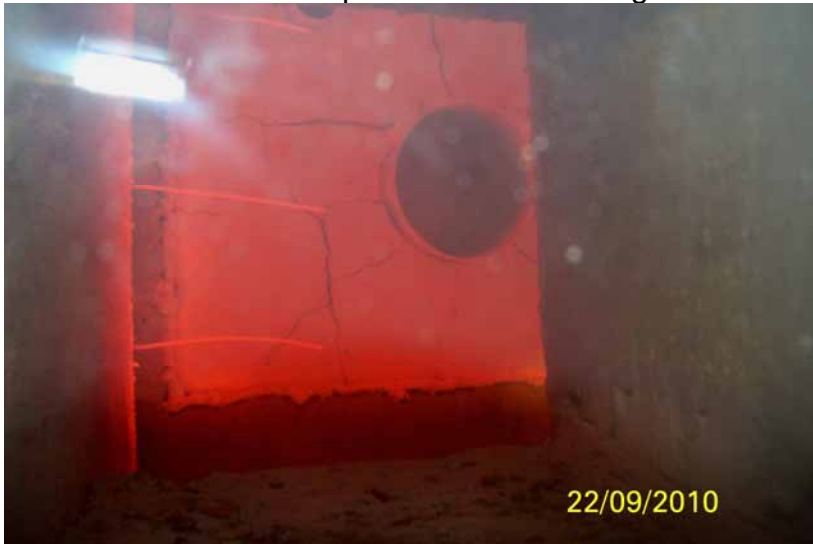
FTP 12 Internal view of plasterboard cracking at 25-30 min's

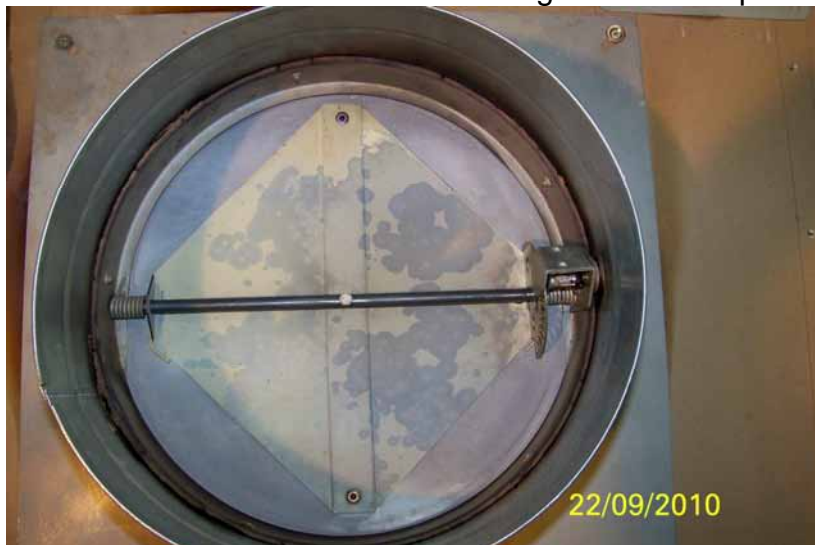
FTP16 Fire test after 50 min's showing 315 dia damper at 883°C

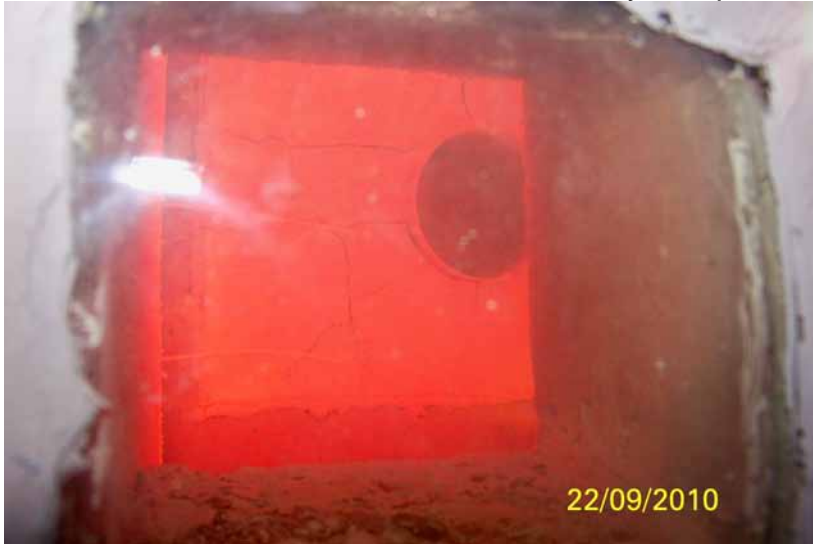
FTP 17 After 55 min's the internal second layer of plasterboard starts to crack

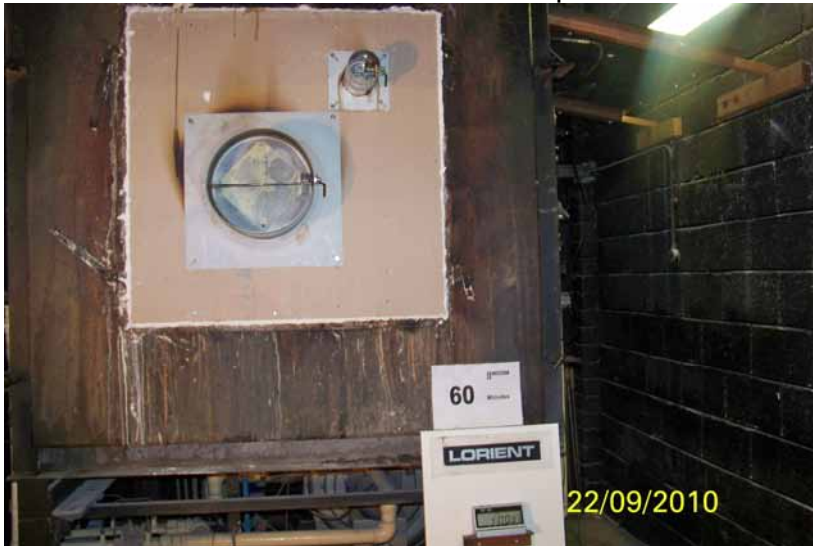
FTP18 After 60 min's the wall and damper are still demonstrating integrity.

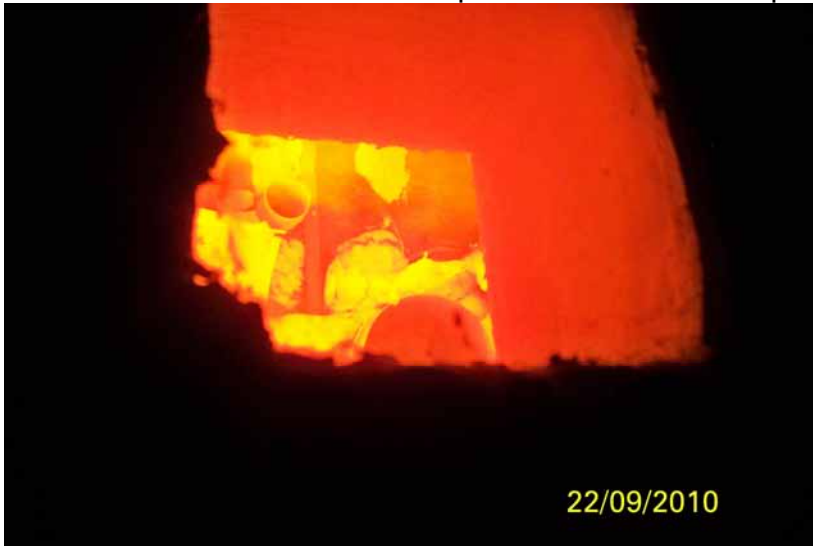
FTP19 After 70 min the internal plasterboard has collapsed exposing the vertical studs.

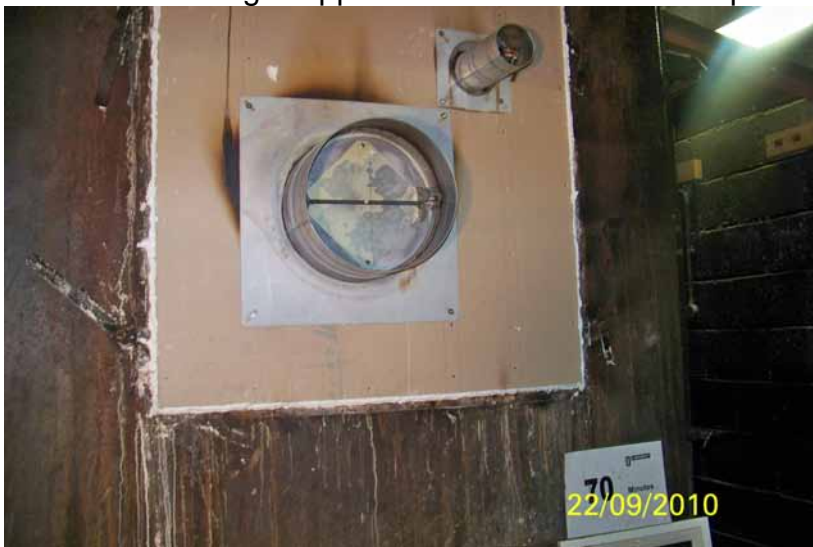
FTP 20 Scorching is apparent on the external front plasterboard.

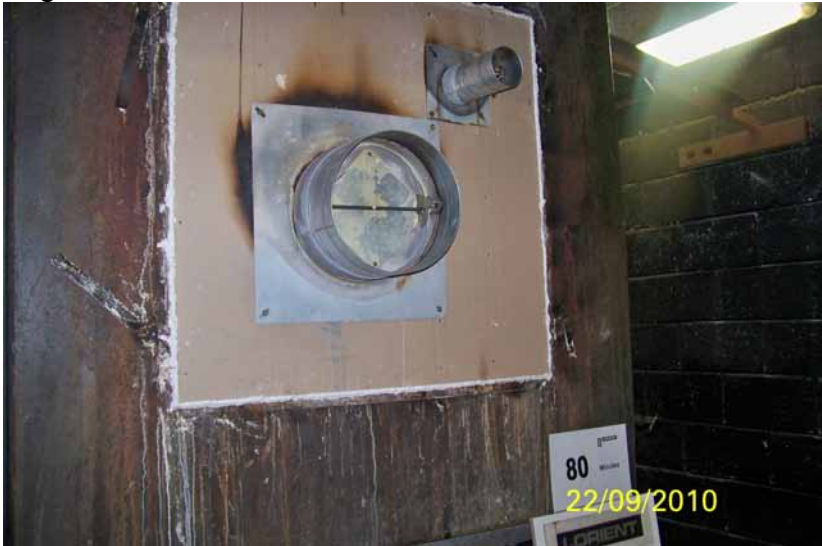
FTP 22 After 80 min's more intense scorching is apparent and the damper blades start to glow.

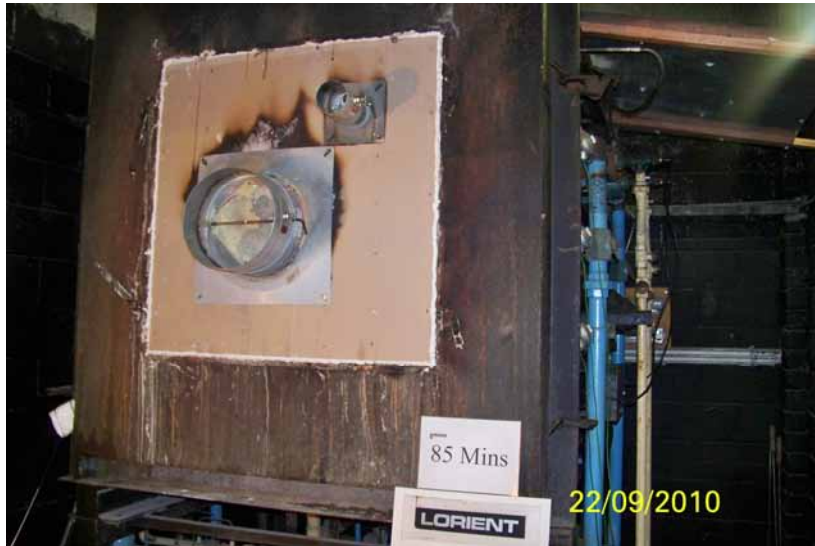
FTP 24 After 85 min's the front of the wall shows sever burn marks and starts to glow.

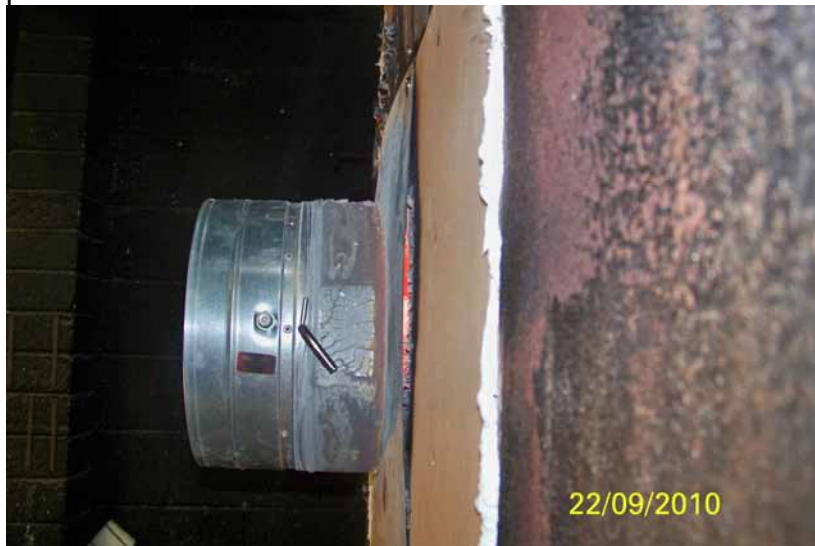
FTP 25 The 315 dia damper can be seen to glow and the frame bows to about 8mm at the middle on the top and both sides due to the destruction of three levels of plasterboard.

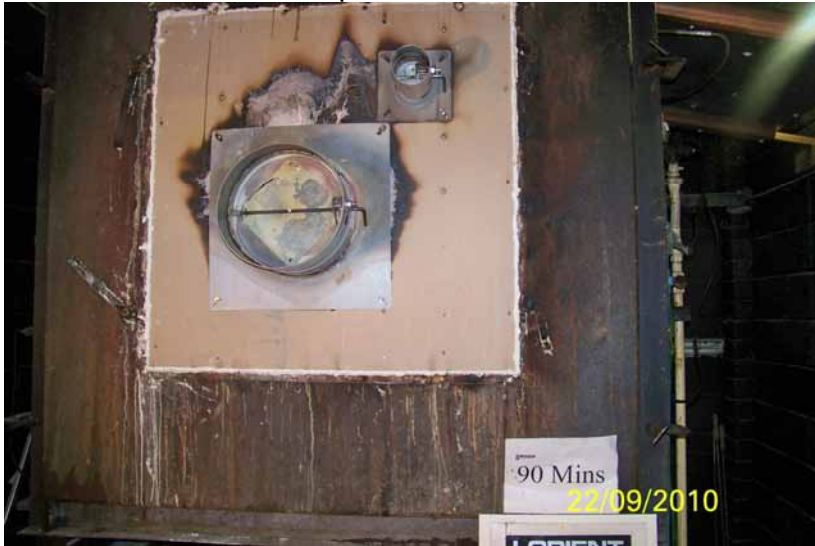
After which the external face of the wall showed signs of cracking and was not considered to maintain its integrity.

FTP 26 After 90 min's 1-2 mm wide cracks appear on the outer layer of plasterboard above the 315 dia damper.

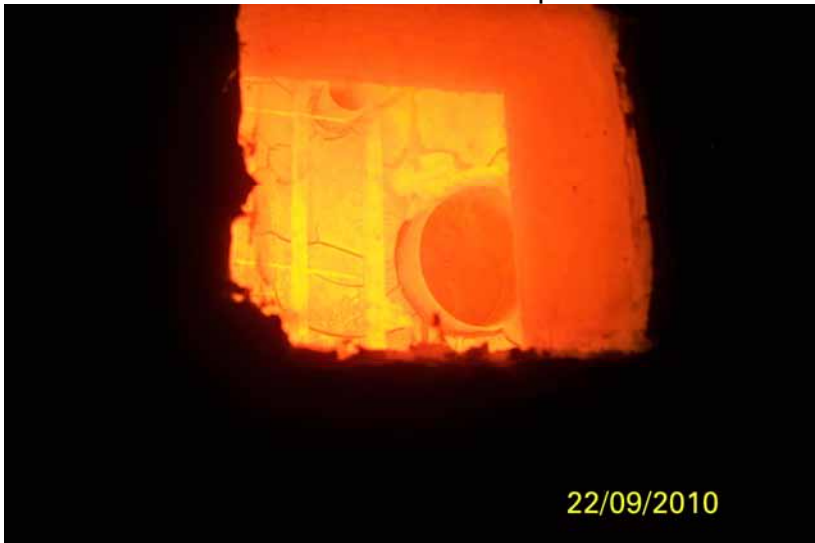
FTP 27 with the time now over 100 min's and the internal temperature of the furnace at 1025°C the wall can be seen to fail in places.

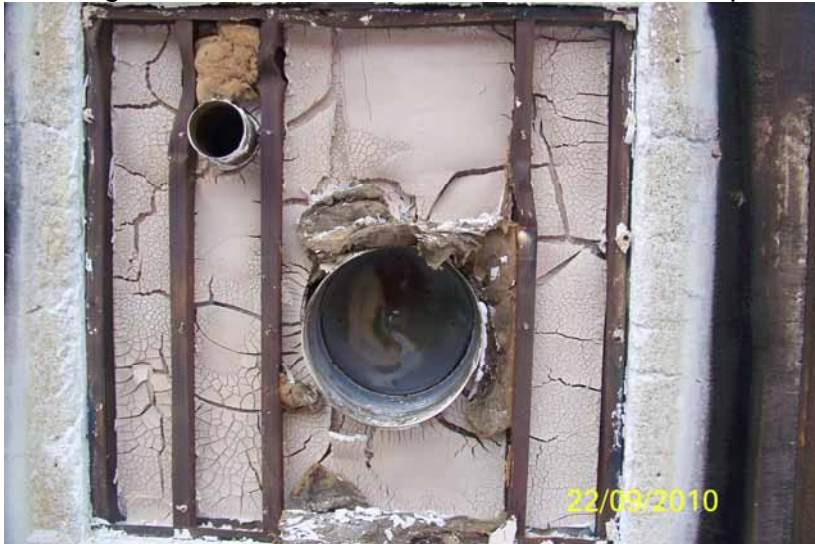
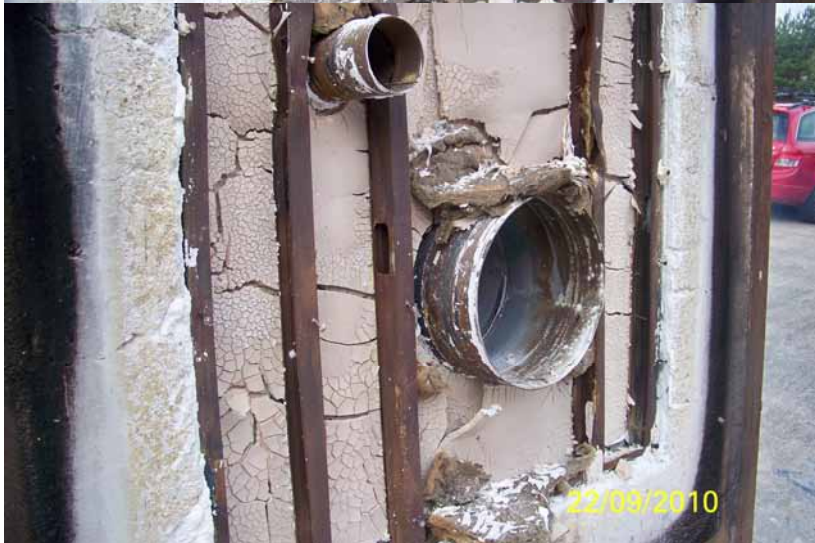
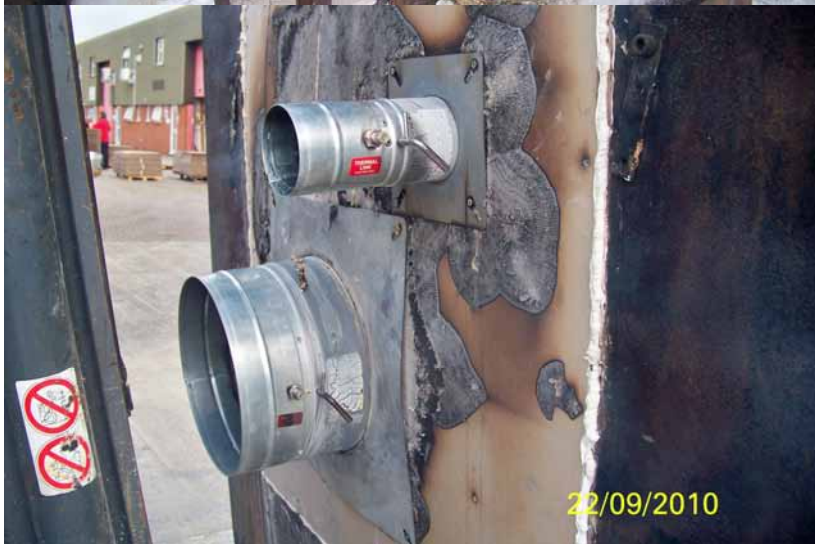
FTP 28, 29 & 30 The test is now complete and the front of the furnace removed, showing a clear view of the internal surface of the specimen wall and dampers.
